# Inspection Report

**Property Address:**  
1234 Pineapple Lane  
Margaritaville FL 12345

**Grey Hawk Home Inspections, LLC**

<b>Date:</b> 1/26/2018	<b>Time:</b> 09:00 AM	<b>Report ID:</b> 012618-Pineapple
<b>Property:</b> 1234 Pineapple Lane Margaritaville FL 12345	<b>Customer:</b> Jimmy Buffet	<b>Real Estate Professional:</b>

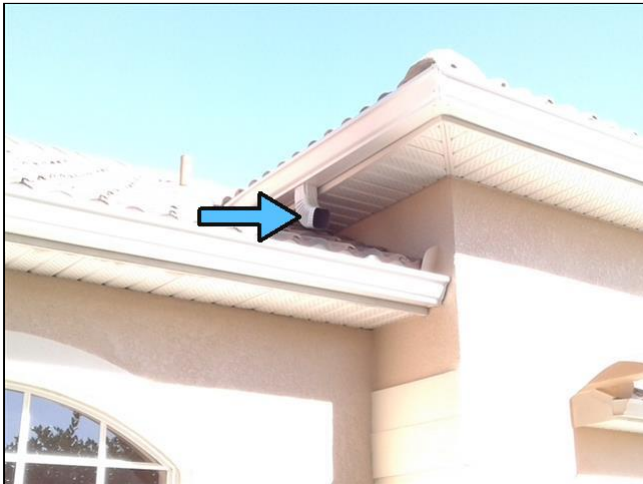
1.3 Item 1(Picture)

Downspout should terminate into gutter below or have a shield installed on gutter below to avoid water overflowing gutter. Suggest a qualified contractor to review and repair.

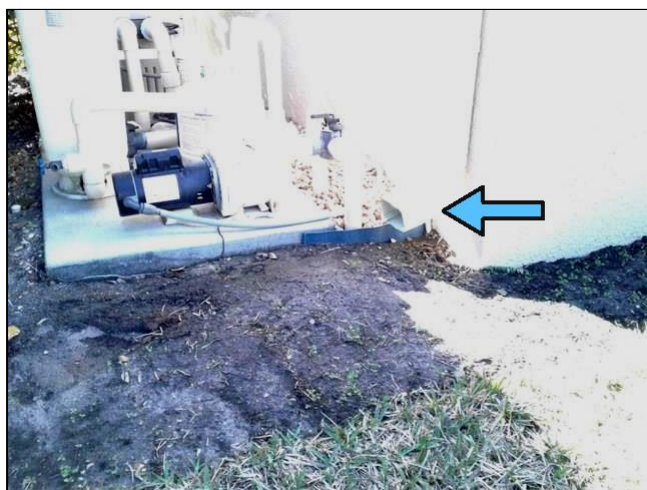
2.4 Item 1(Picture)

(1) Downspout at Northwest corner of the residence needs an extension piece installed. Water should be directed further away from the building to avoid erosion and water damage to the structure. Suggest a qualified gutter contractor to review and make repairs.

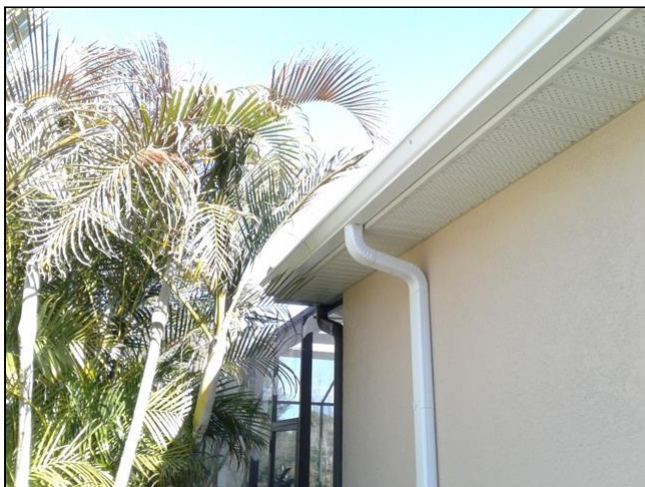
2.4 Item 3(Picture)

(3) Palm branches should be trimmed to stay off or above roof. Palm branches can damage the tile roof and can collect in the downspout / gutter system and cause overflow issues. Suggest a landscaper to trim back branches.

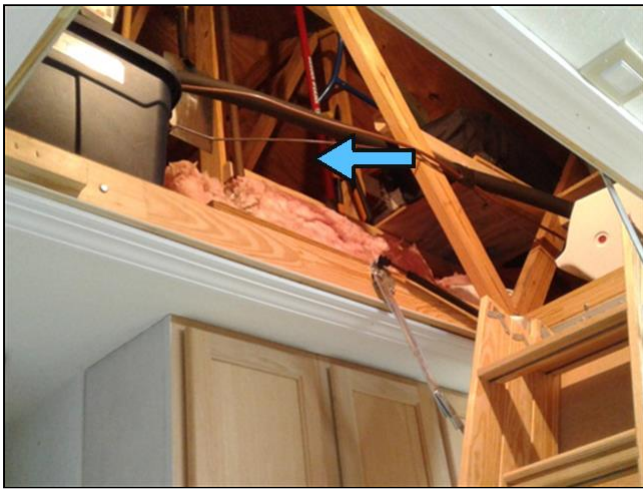
3.1 Item 1(Picture)

The firewall in the attic space is missing. The ceiling in the garage with the pull down stairway is not a rated partition and would allow a fire in the garage to spread into and thru the attic above the living spaces.. This is considered unsafe until corrected. A qualified person should correct for safety.

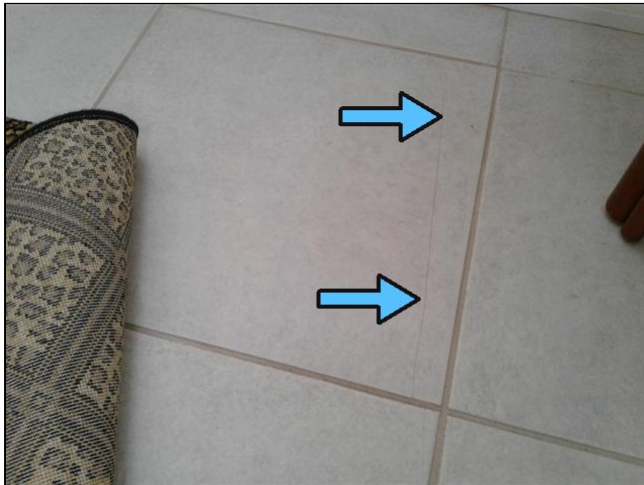
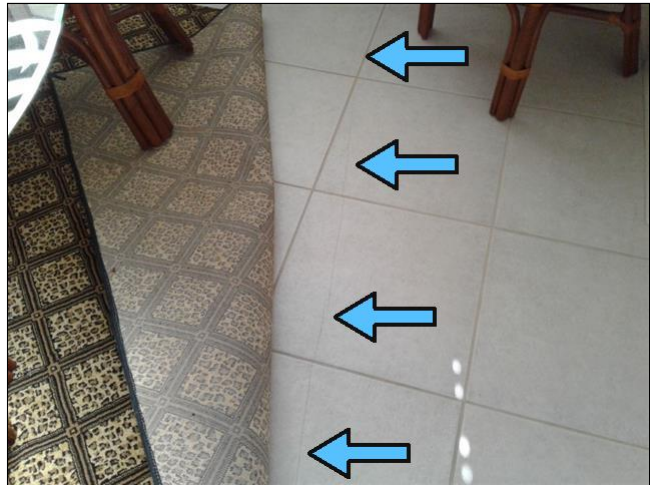
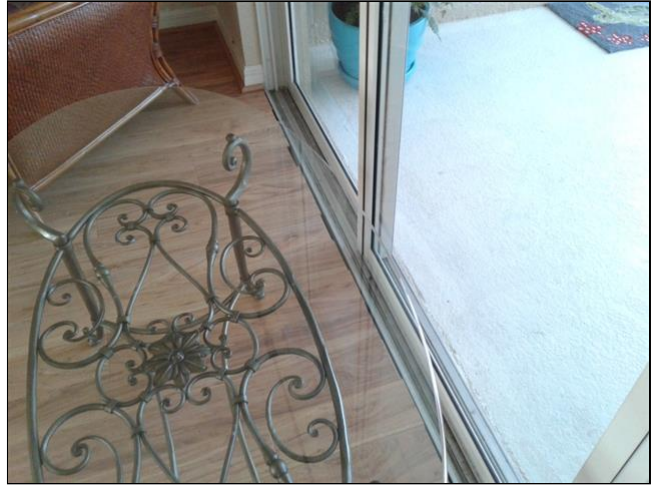
Pictures 1 thru 3 depict a crack in the Dining room floor under the carpet. The ceramic tile is cracked for approximately 7 feet. Suggest contacting the current owner to see if this is a new crack or if it is an old settlement crack. Also inquire if owner has any replacement tile.

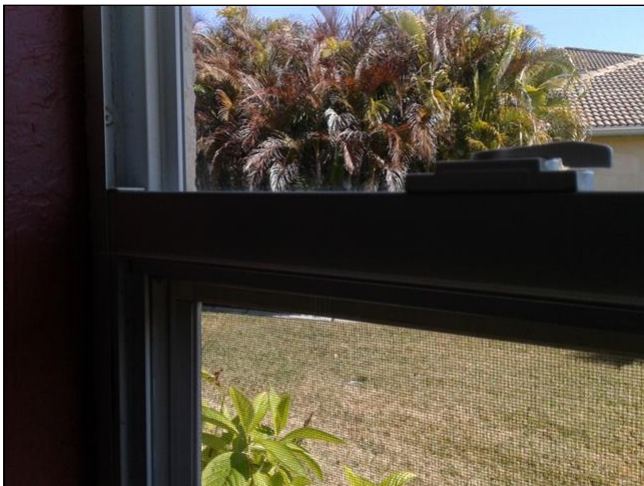
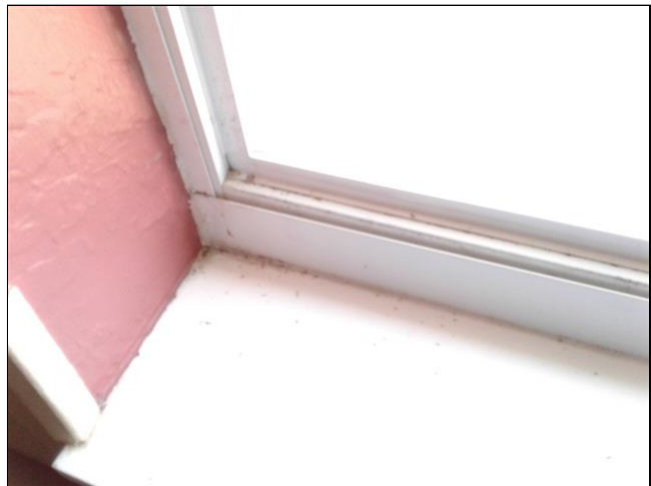
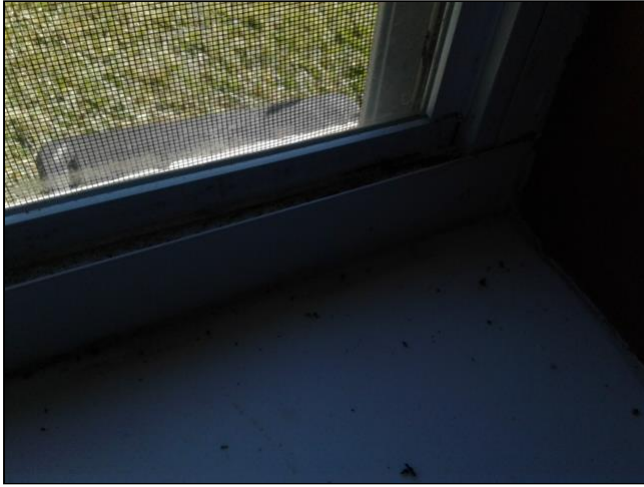
The window in Bedroom #3 is inoperable. The left side will not fully close or lock. This should be inspected by a qualified window contractor.

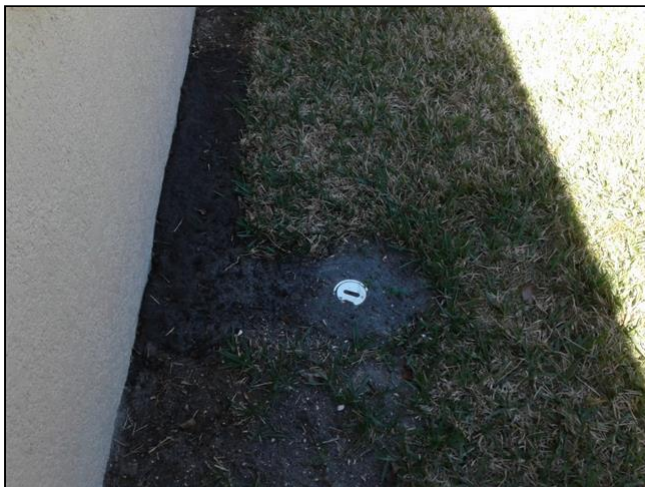
6.0 Item 1(Picture)

This is a clean out plug for the plumbing waste line exiting the residence on the west side of the building. In case the waste system backs up in the future, this plug will need to be accessed.

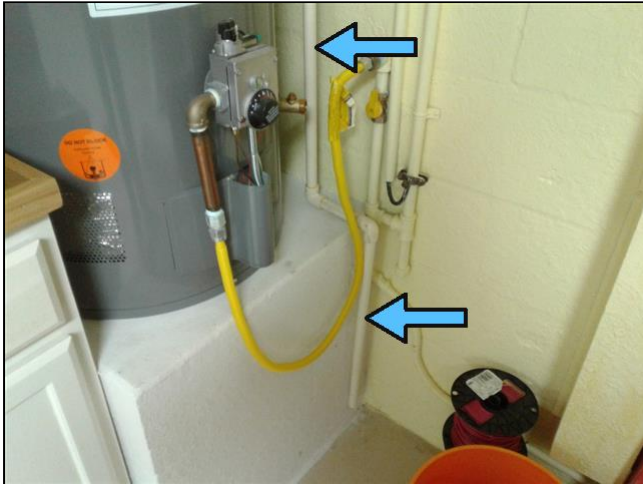
6.1 Item 1(Picture)

The discharge piping on the domestic water heater from the thermostatic temperature / pressure valve is not secured at any point after the valve itself. This may cause the piping to break off and expose occupant to high temperature discharge water. Suggest a qualified plumber review and repair.

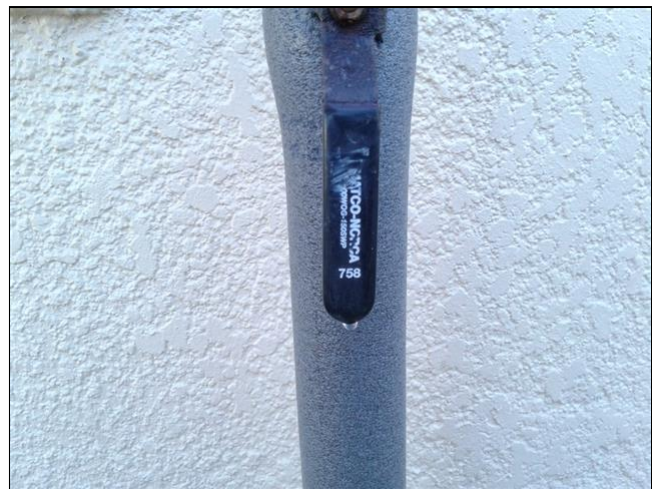
This is the main water shut off for the residence. It is located near the hose bib on the West side of the house. The valve appears to have a small leak and should be inspected by a qualified plumber. There are 2 backflow preventers at the Southwest corner of the property adjacent the water meter pit. Picture 3 identifies the these items. The water meter is at the lower left in the picture. The backflow preventer on the left is for the domestic water in the residence. The backflow preventer on the right is for the lawn irrigation system. The associated valves with these backflow preventers would also shut off their associated systems.

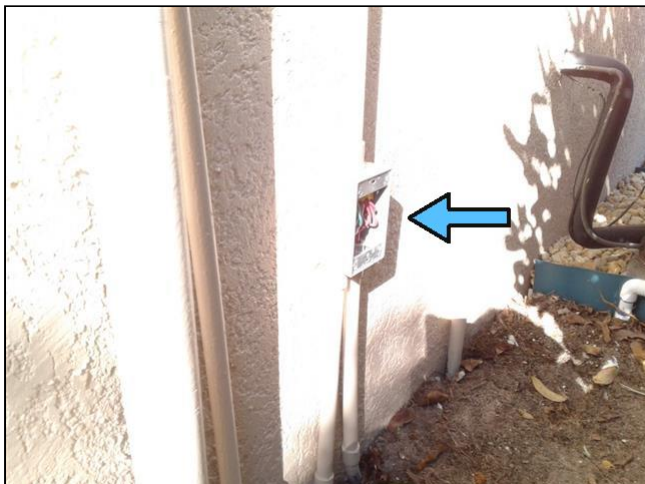
7.3 Item 1(Picture)

(1) This Electrical box on the exterior near the A/C condensing unit on the East side of the house need a blank cover plate installed. Open wiring exposed to animals and or children is a safety issue. Suggest a qualified electrician review and repair.

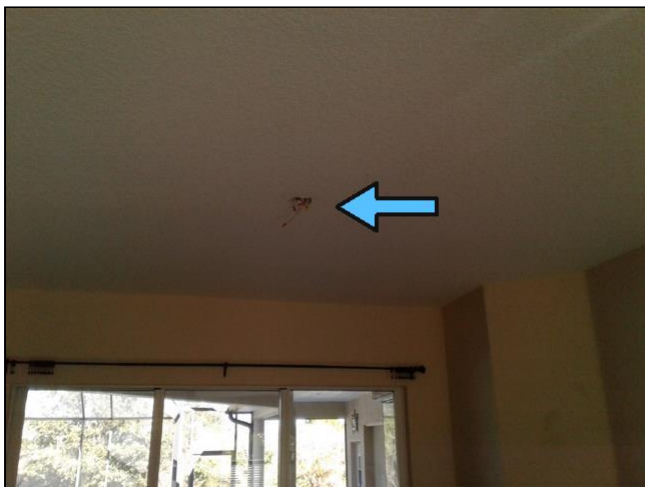
7.3 Item 2(Picture)

(2) This is an open electrical box in the ceiling of the Front living room. This needs to have a fixture installed or a blank cover plate for safety. Suggest a qualified electrician to review or repair.

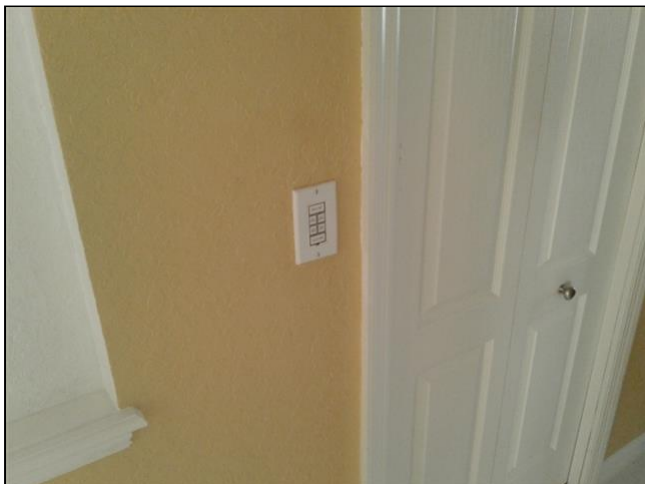
7.3 Item 3(Picture)

(3) This switch in the Master bedroom hallway does not operate the hall lights above or any other items shown on the key pad. Suggest a qualified electrician repair or replace.

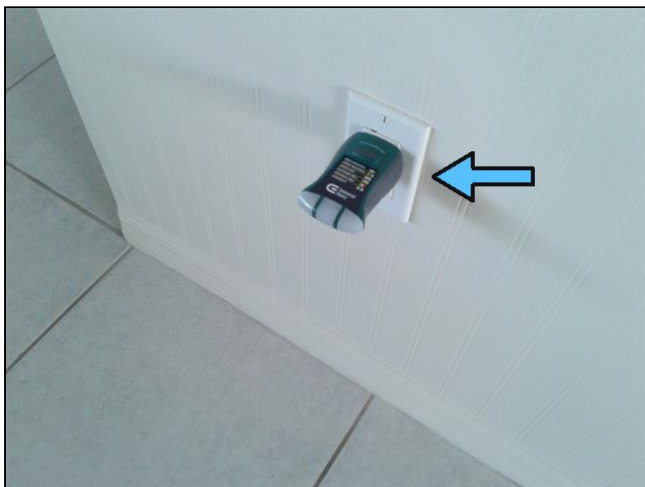
7.5 Item 1(Picture)

This GFCI outlet on the Kitchen island is inoperative. Suggest a qualified electrician review and repair.

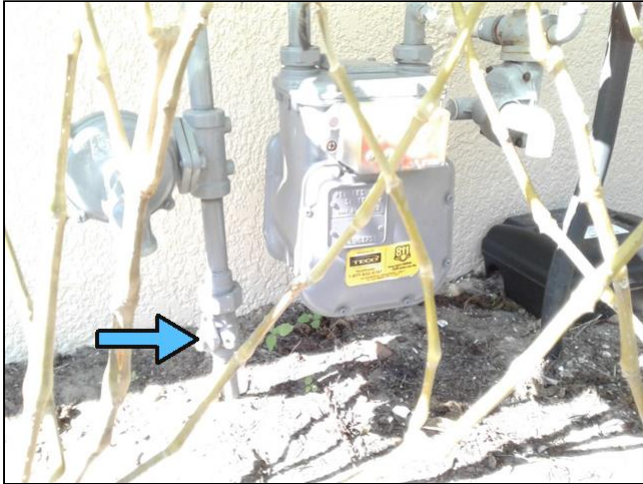
8.0 Item 2(Picture)

(2) This is the location of the main shut off valve for the natural gas to the residence. It is located next to the gas meter on the East side of the house.

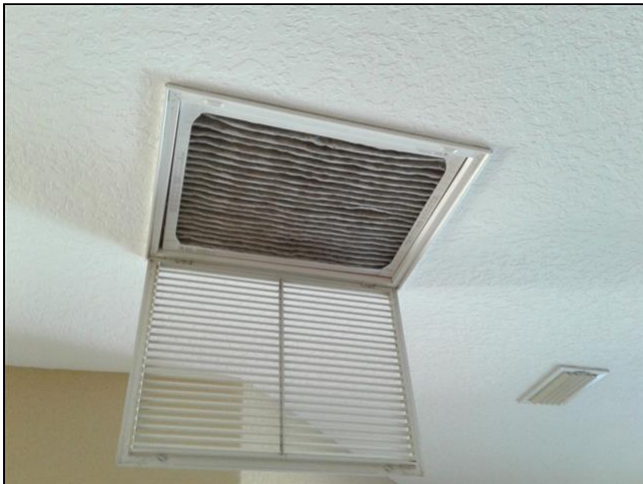
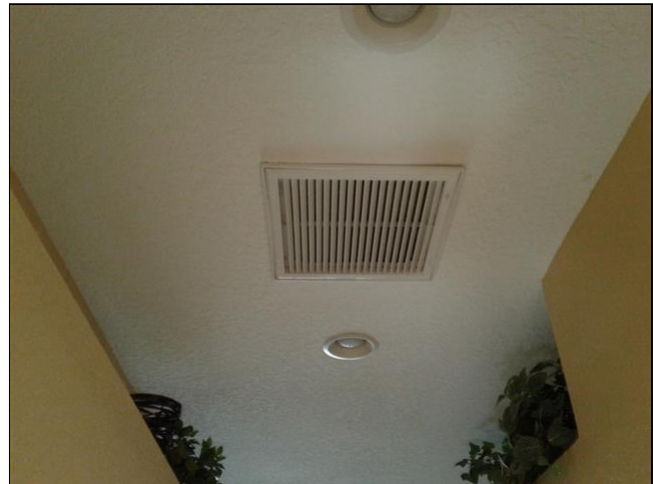
The filters in the return air inlets located in the kitchen and master bedroom ceilings are dirty and need replacement. They are 18 x 24 and 16 x 16 respectively.

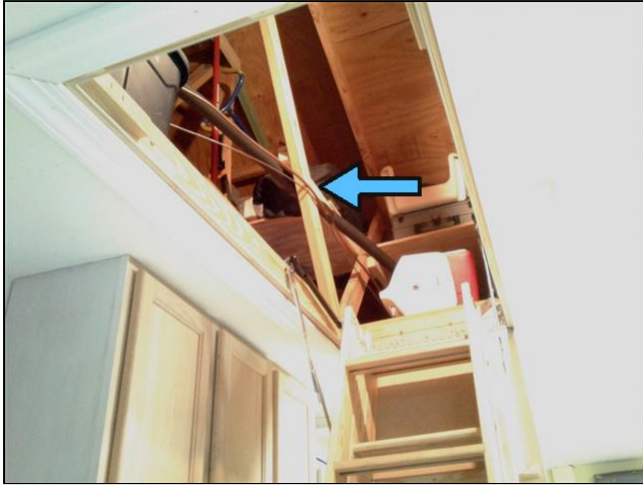
8.8 Item 1(Picture)

The refrigerant lines from the air handler to the outdoor condensing unit pass thru the pull down stair opening into the attic above the garage. This piping is not properly supported and will, over time be subjected to possible damage due to loading of the attic storage items. Suggest a qualified HVAC contractor review and repair.

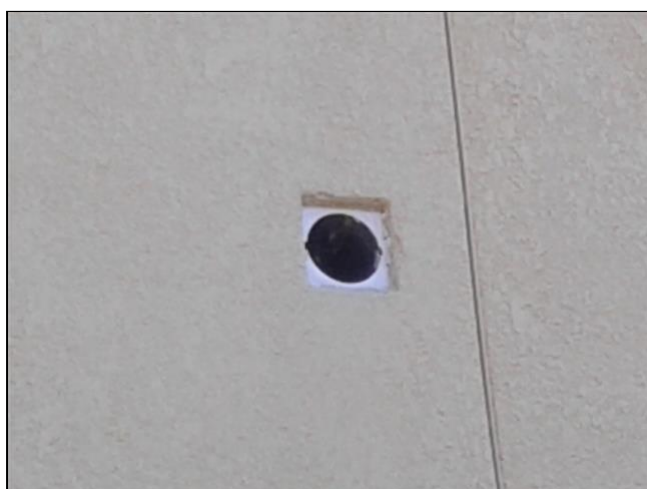
9.4 Item 1(Picture)

This is the dryer exhaust outlet on the East side of the house. It is missing the outside hood and damper assembly. This allows water and animals to enter the duct and residence. Suggest a qualified HVAC contractor to review and repair.

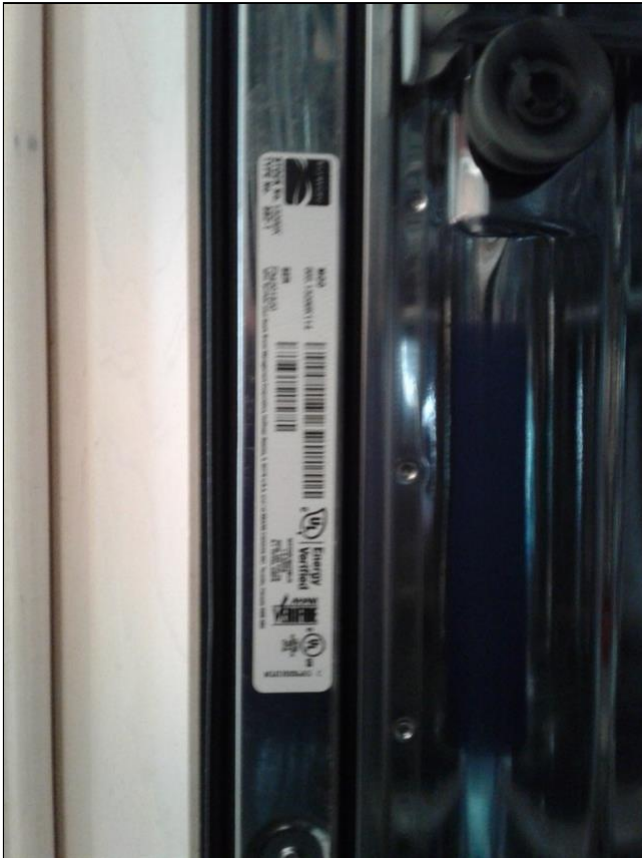
10.0 Item 1(Picture)

Dishwasher is a Kenmore Model 665.13269K114 S/N F34201820

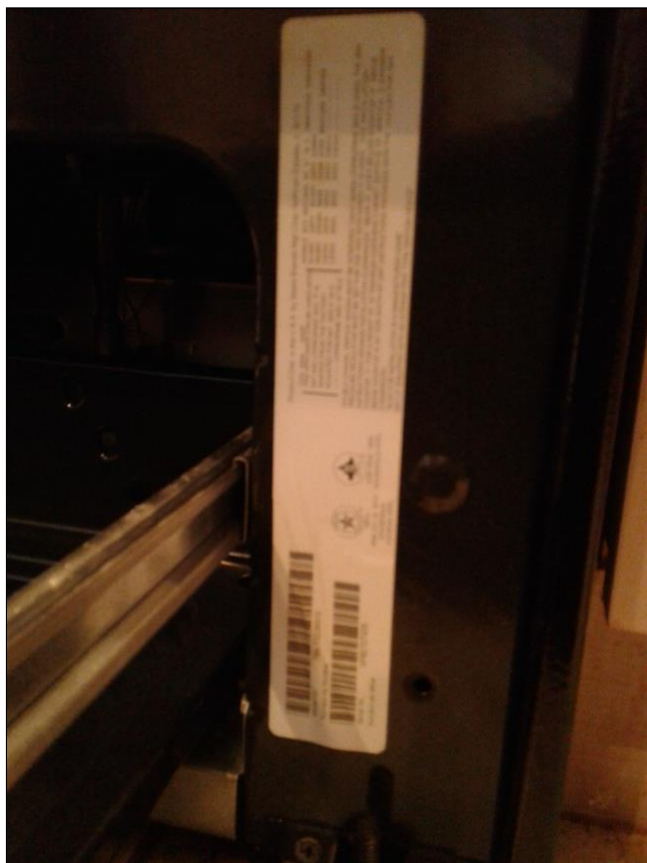
10.1 Item 1(Picture)

Range / Oven is a Kenmore Model 790.73239313 S/N VF62727325

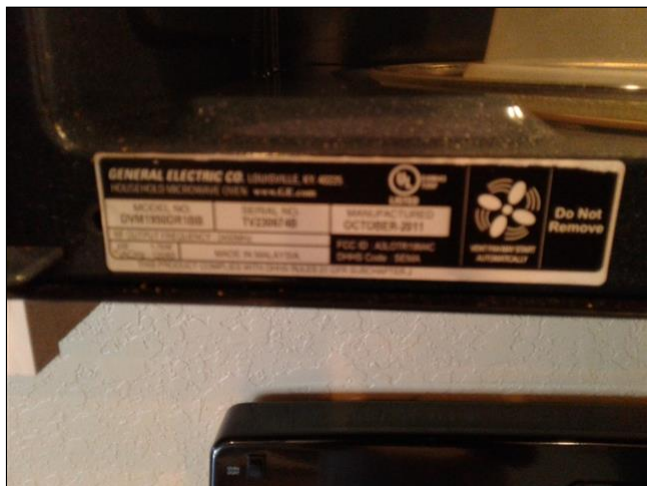
10.5 Item 1(Picture)

Microwave is a GE Model DVM1950DR1BB S/N TV230674B Manufactured in Oct 2011

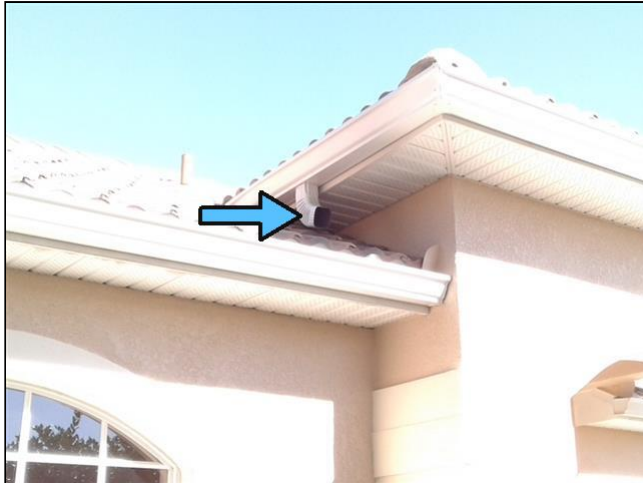
1.3 Item 1(Picture)

Downspout should terminate into gutter below or have a shield installed on gutter below to avoid water overflowing gutter. Suggest a qualified contractor to review and repair.

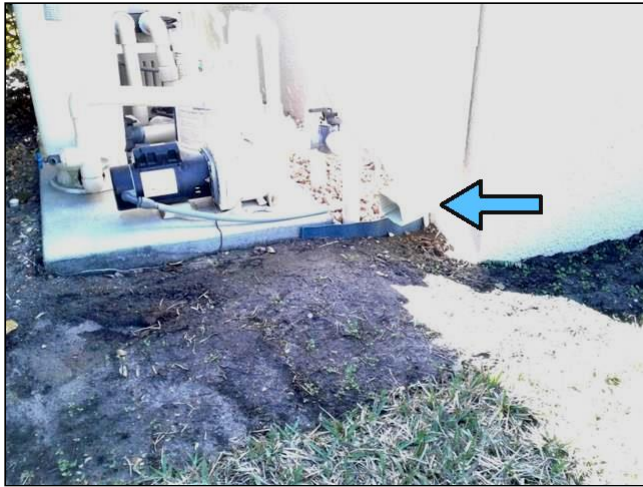
2.4 Item 1(Picture)

(1) Downspout at Northwest corner of the residence needs an extension piece installed. Water should be directed further away from the building to avoid erosion and water damage to the structure. Suggest a qualified gutter contractor to review and make repairs.

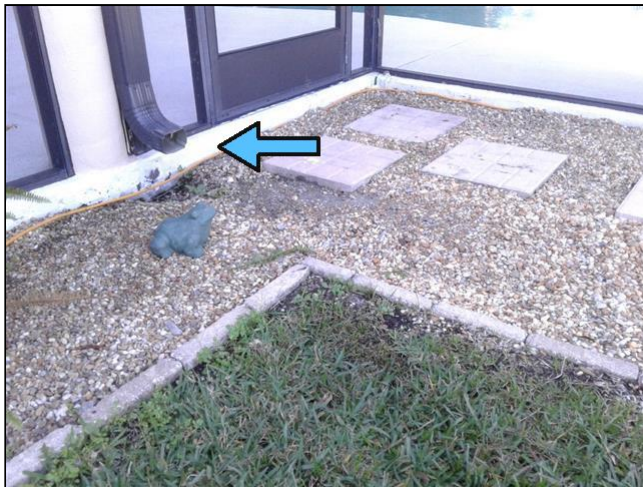
2.4 Item 2(Picture)

(2) Downspout at the North side of the residence need to have an extension piece installed. Water should be directed further away from the building to avoid erosion and water damage to the structure. Suggest a qualified gutter contractor to review and make repairs.

(2) Downspout at the North side of the residence need to have an extension piece installed. Water should be directed further away from the building to avoid erosion and water damage to the structure. Suggest a qualified gutter contractor to review and make repairs.

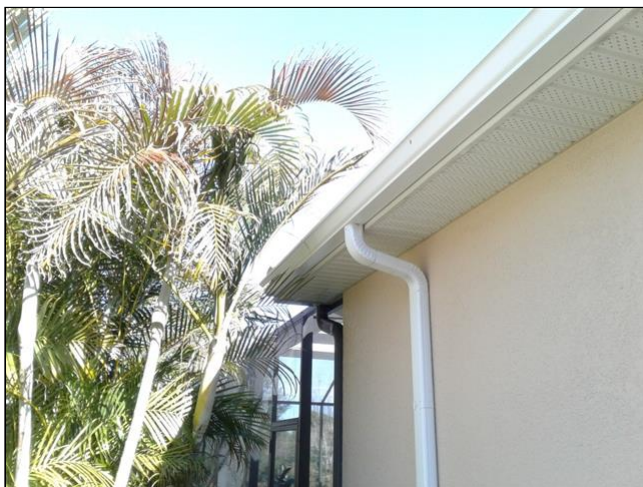
2.4 Item 3(Picture)

(3) Palm branches should be trimmed to stay off or above roof. Palm branches can damage the tile roof and can collect in the downspout / gutter system and cause overflow issues. Suggest a landscaper to trim back branches.

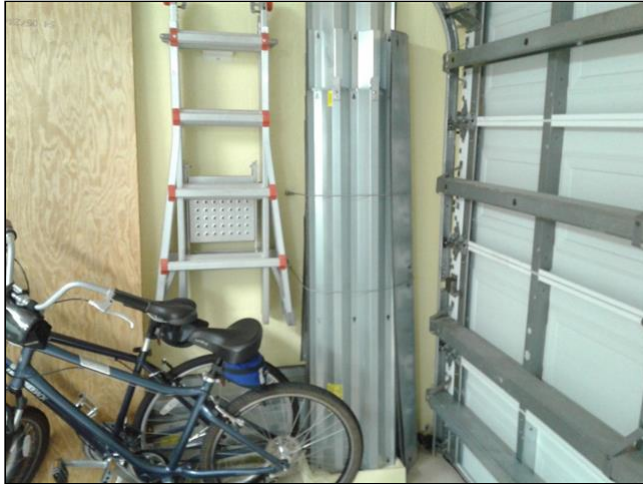
2.6 Item 1(Picture)

The corrugated metal Hurricane shutters are stored in the corner of the garage. Suggest discussing with the owner the location of all hardware, sketches, or installation instructions.

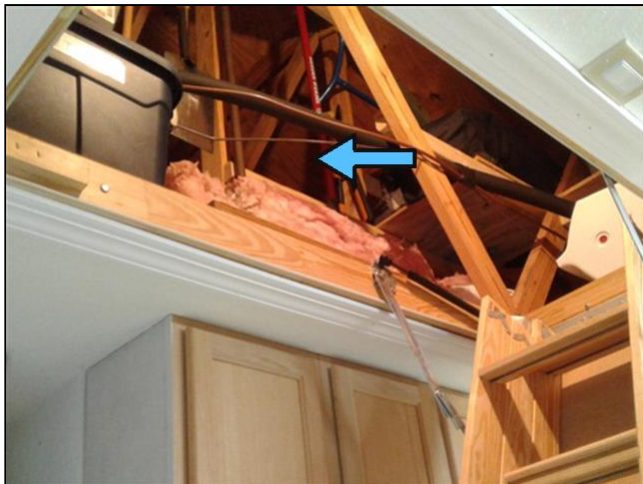
3.1 Item 1(Picture)

The firewall in the attic space is missing. The ceiling in the garage with the pull down stairway is not a rated partition and would allow a fire in the garage to spread into and thru the attic above the living spaces.. This is considered unsafe until corrected. A qualified person should correct for safety.

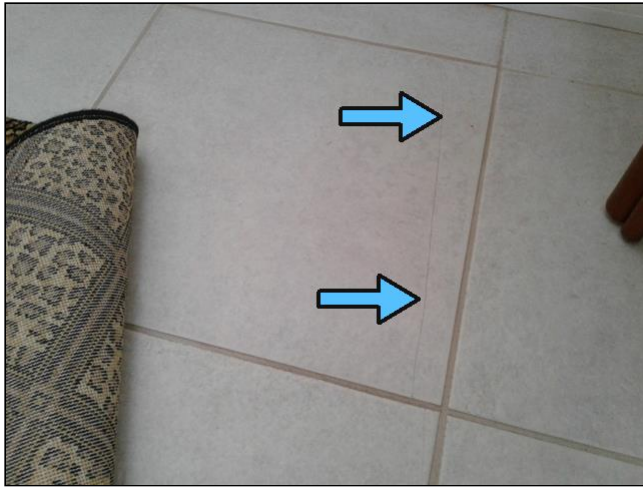
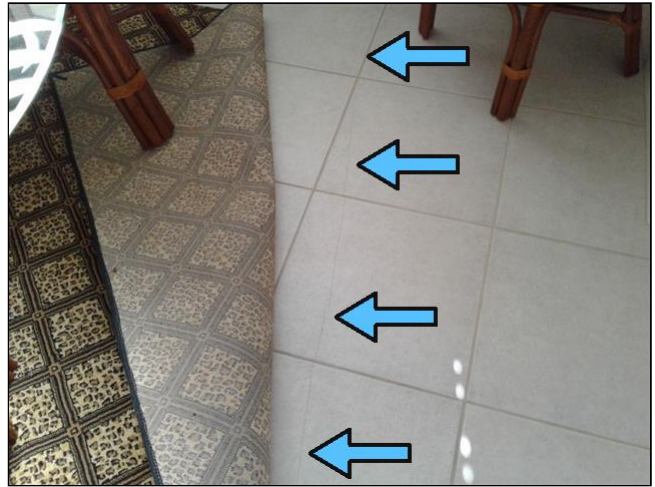
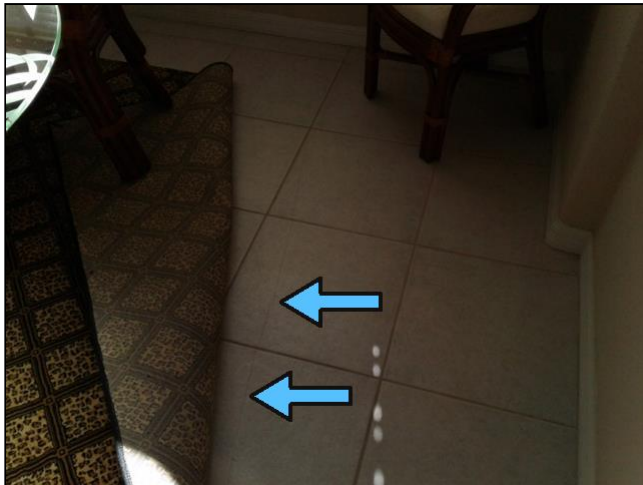
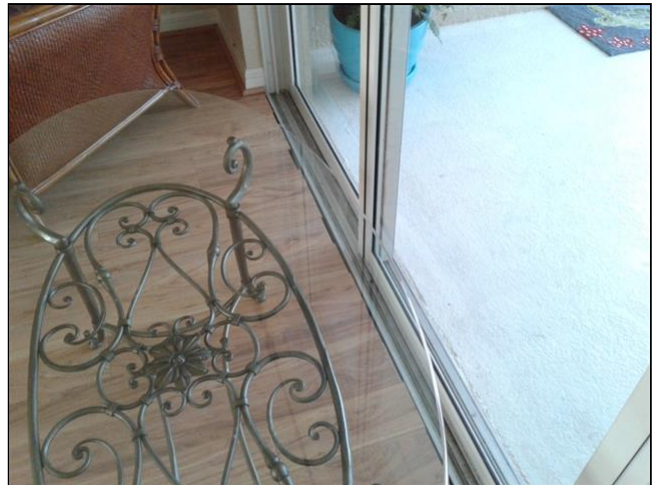
Pictures 1 thru 3 depict a crack in the Dining room floor under the carpet. The ceramic tile is cracked for approximately 7 feet. Suggest contacting the current owner to see if this is a new crack or if it is an old settlement crack. Also inquire if owner has any replacement tile.

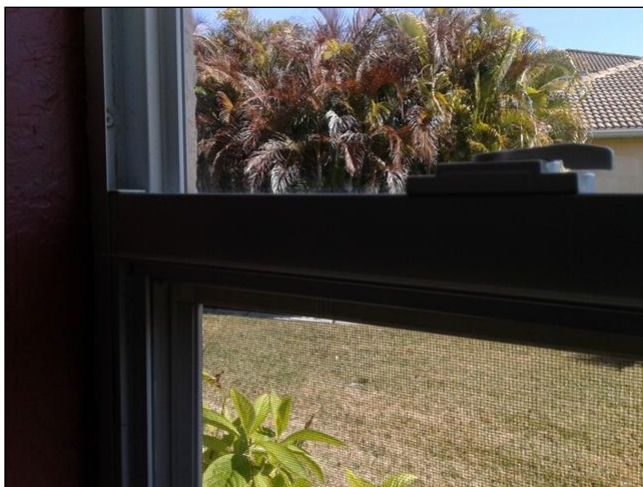
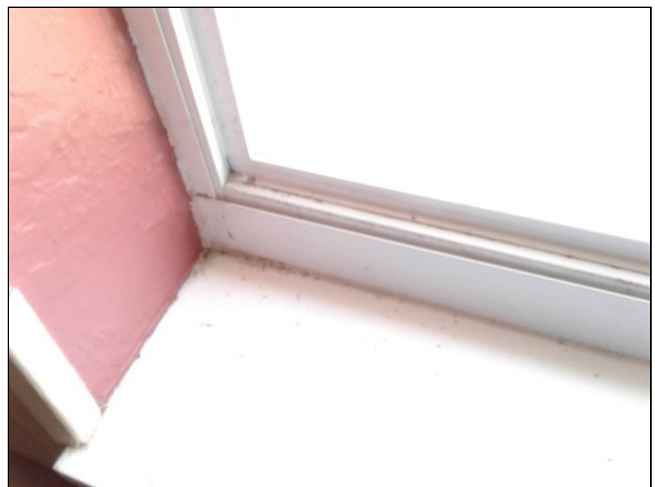
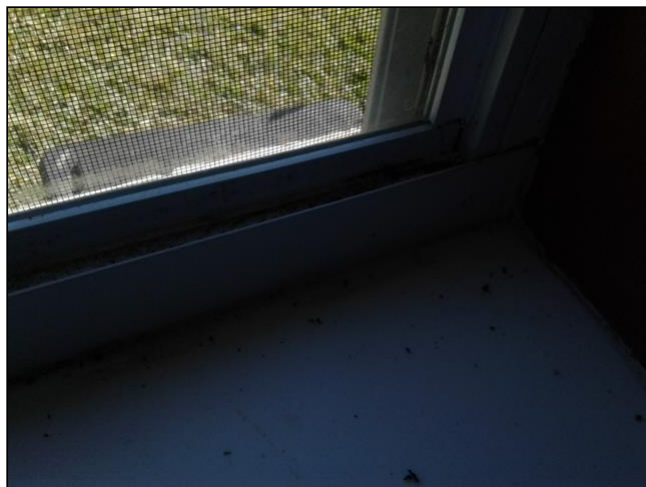
The window in Bedroom #3 is inoperable. The left side will not fully close or lock. This should be inspected by a qualified window contractor.

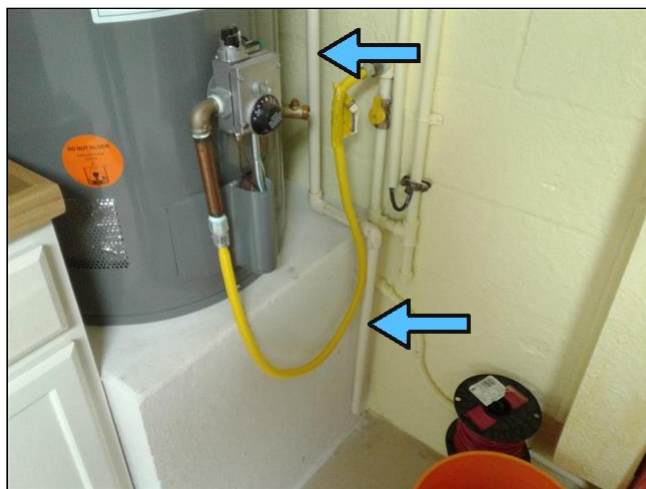
6.1 Item 1(Picture)

The discharge piping on the domestic water heater from the thermostatic temperature / pressure valve is not secured at any point after the valve itself. This may cause the piping to break off and expose occupant to high temperature discharge water. Suggest a qualified plumber review and repair.

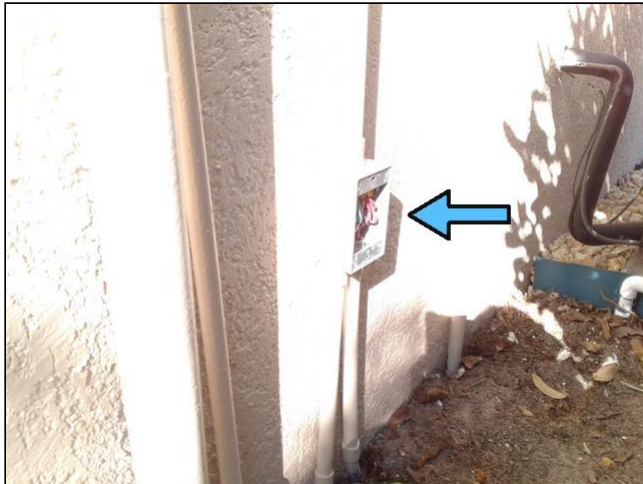
7.3 Item 1(Picture)

(1) This Electrical box on the exterior near the A/C condensing unit on the East side of the house need a blank cover plate installed. Open wiring exposed to animals and or children is a safety issue. Suggest a qualified electrician review and repair.

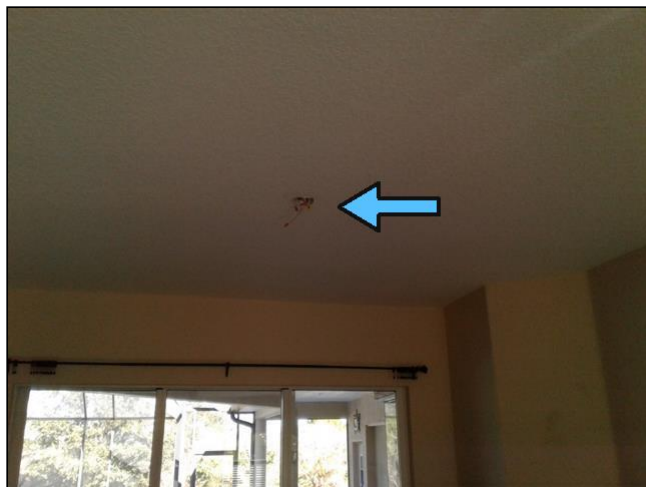
7.3 Item 2(Picture)

(2) This is an open electrical box in the ceiling of the Front living room. This needs to have a fixture installed or a blank cover plate for safety. Suggest a qualified electrician to review or repair.

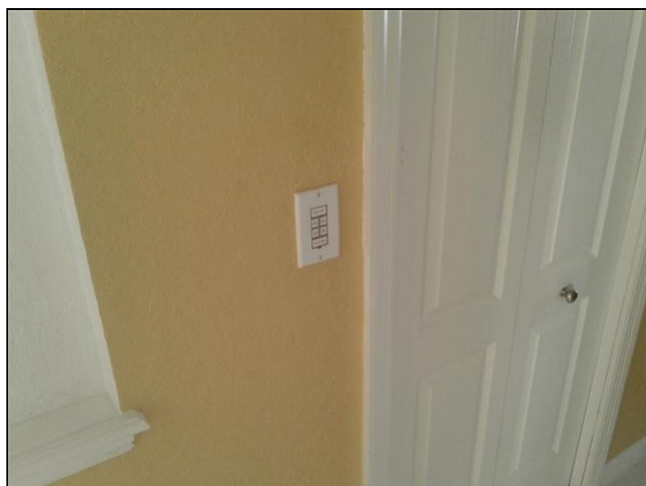
7.3 Item 3(Picture)

(3) This switch in the Master bedroom hallway does not operate the hall lights above or any other items shown on the key pad. Suggest a qualified electrician repair or replace.

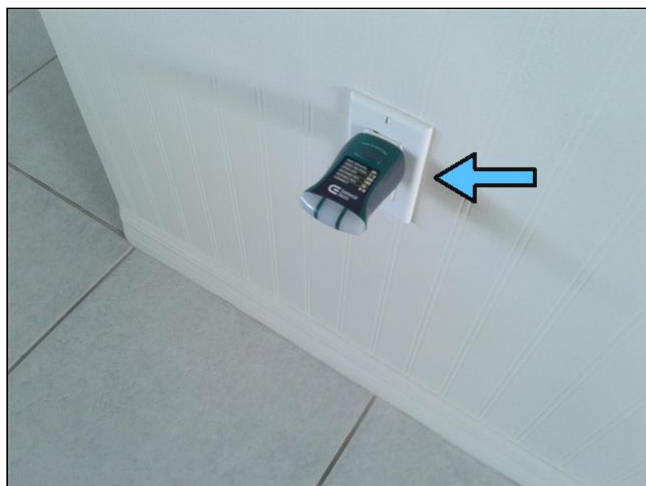
7.5 Item 1(Picture)

This GFCI outlet on the Kitchen island is inoperative. Suggest a qualified electrician review and repair.

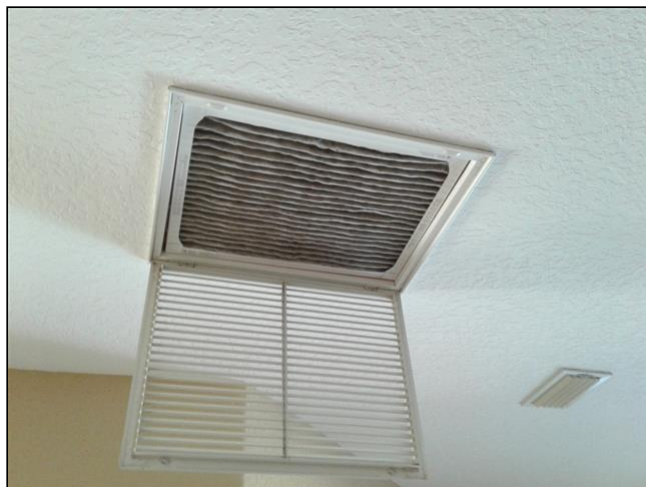
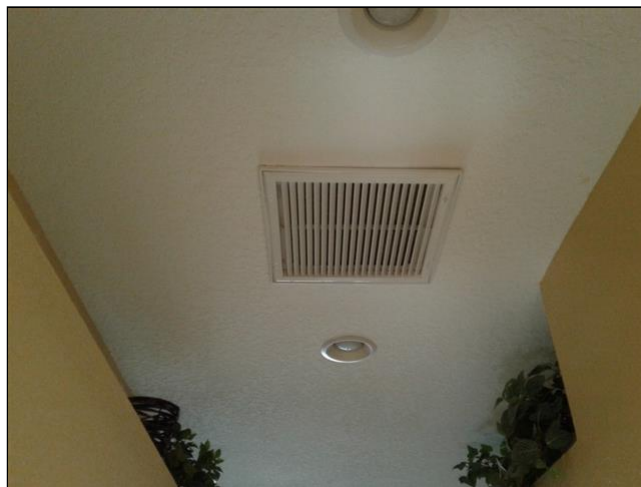
The filters in the return air inlets located in the kitchen and master bedroom ceilings are dirty and need replacement. They are 18 x 24 and 16 x 16 respectively.

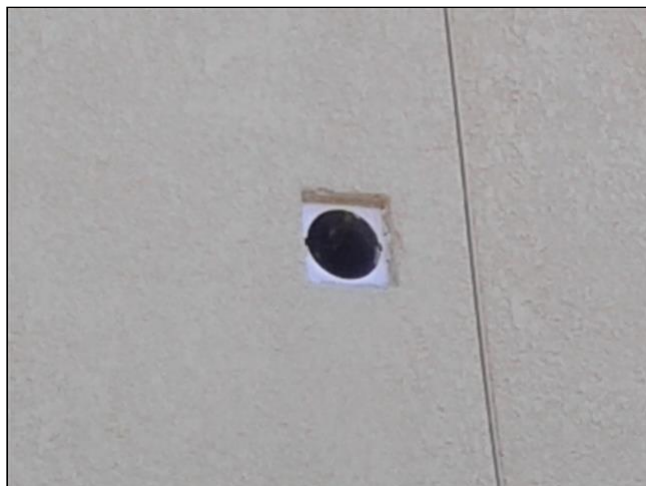
9.4 Item 1(Picture)

This is the dryer exhaust outlet on the East side of the house. It is missing the outside hood and damper assembly. This allows water and animals to enter the duct and residence. Suggest a qualified HVAC contractor to review and repair.
